Report 1443

THE EFFECTS OF ATOMIC WEAPONS ON ENGINEER HEAVY EQUIPMENT (U)

Project 8-12-75-001

25 April 1956

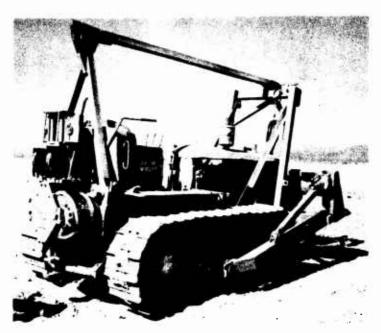
A13096

light damage to the protected tractors. Figs. 4 and 5 show a typical setup and illustrate the condition of the equipment used.

Fig. 4. Caterpillar D-6 bulldozer, 1600 ft; before test.

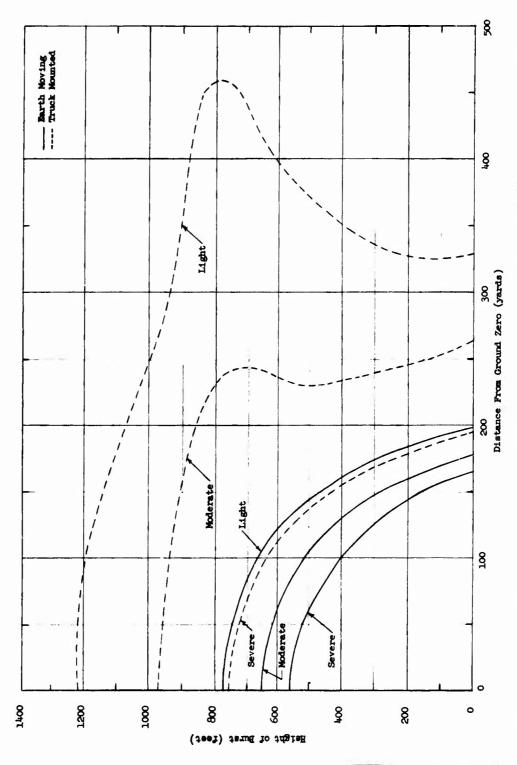
Fig. 27. Height of burst versus ground range damage to protected Engineer equipment scaled to 1 KT.

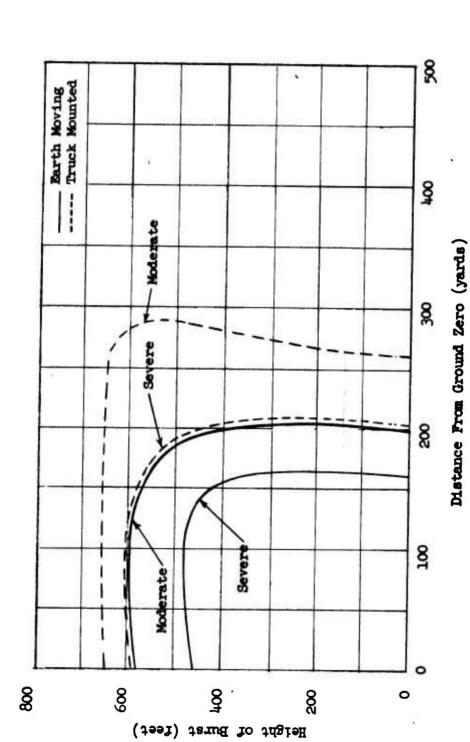
Fig. 28. Height of burst versus ground range damage to exposed Engineer equipment scaled to 1 KT.
